3D Modeling of Lockheed Electra Model 10E and Analysis of Video Footage from the TIGHAR 2010 Nikumaroro Expedition

By: Jay Vincelli, MSc

February 28, 2014

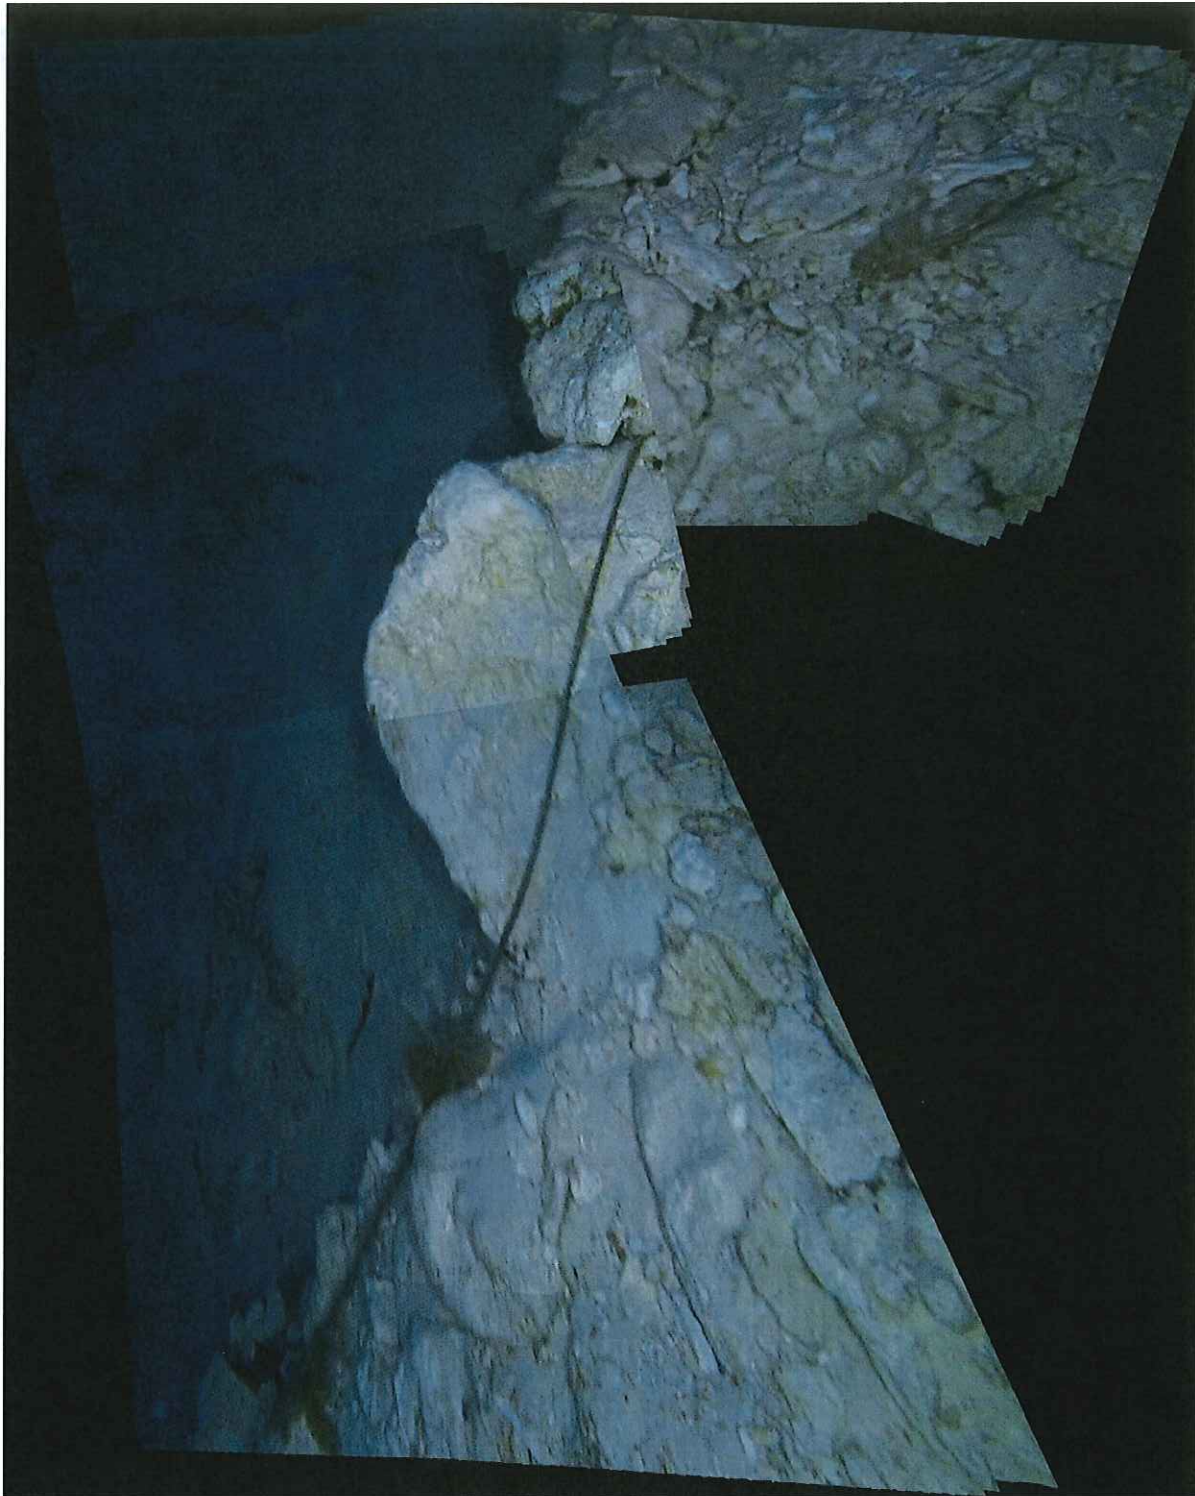
Figure 1: This composite image from the 2010 1920x1080 rover footage, created by Fatih Calakli, illustrates the proximity of the front and rear landing gears.

These 3D models were rotated and superimposed on proposed objects from still images taken from the 2010 rover video using a perspective view. Screenshots and composite screenshots provided by Fatih Calakli illustrated a cable which could be independently measured based on the 3D models of the front and rear landing gear assemblies and their overlaid positions in the rover images. The relative size and shape of multiple geometric elements were used to positively identify geometric congruence between proposed objects and actual plane parts.

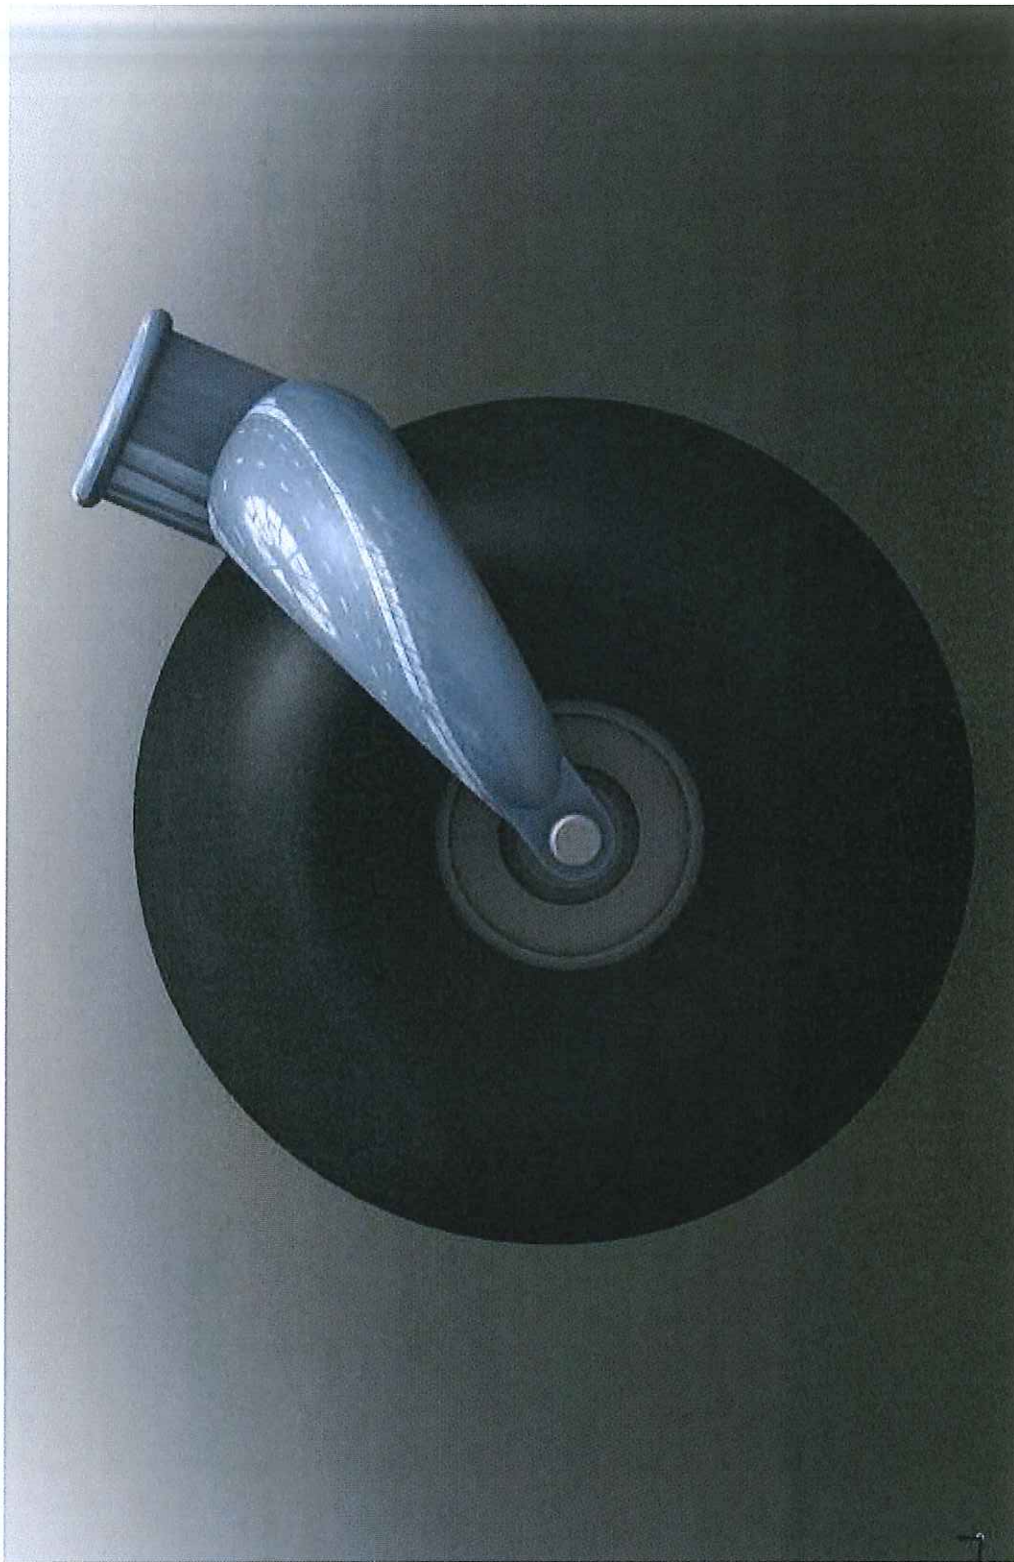
Figure 4: CAD model based on Earhart photo with 16 inch wheel (Earhart inspection report).

The geometry of specific, engineered plane components was 3D modeled using Solidworks, an industry-leading CAD modeling software package. Historical photographs taken of Amelia Earhart's Electra Model 10E aircraft, measurements taken from Grace McGuire's Electra 10 aircraft, and tire information from Earhart's aircraft inspection (Figure 3) were used to determine the dimensions of the models.

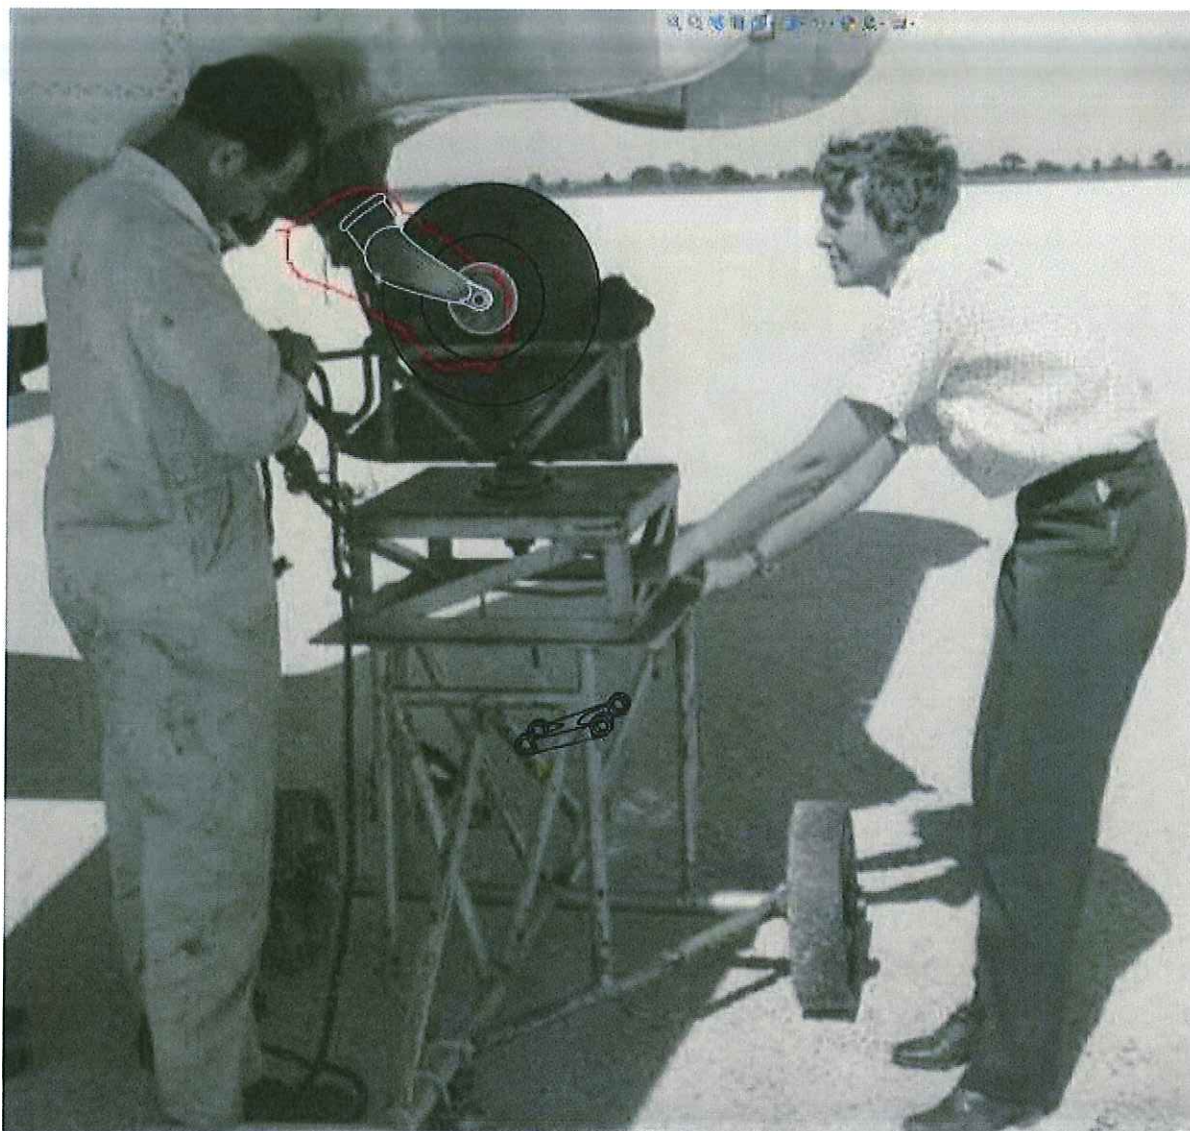
Figure 5: The rear landing gear with Amelia Earhart prior to her Miami departure.
(http://tighar.org/Projects/Earhart/Archives/Research/Bulletins/05_Skullduggery/05_Skullduggery.html).
Photo from: <http://tighar.org/smf/index.php?topic=571.165>

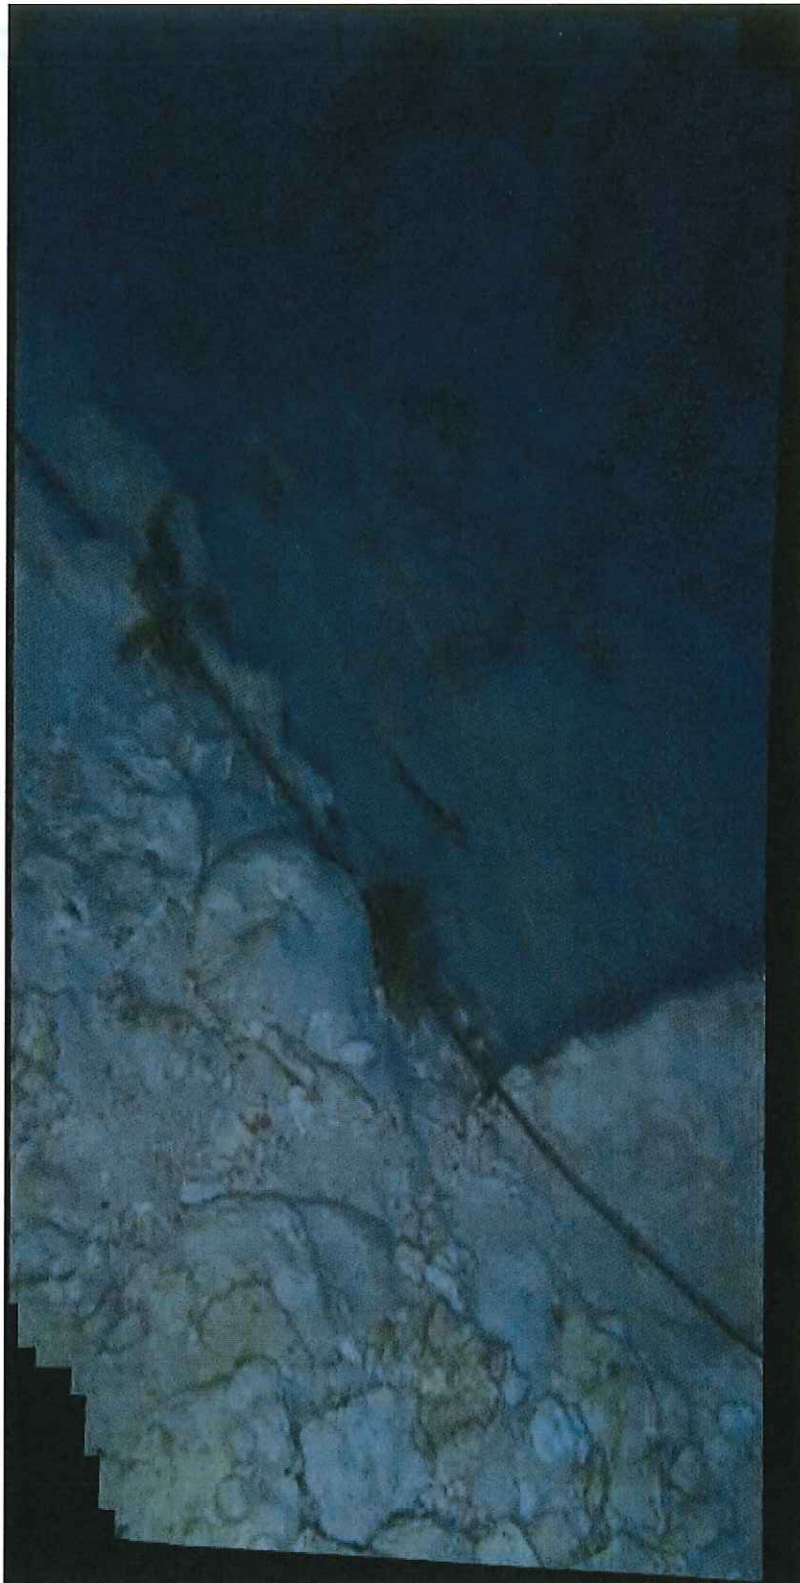
Figure 6: A composite image of the proposed rear landing gear from the 2010 1920x1080 rover video, created by Fatih Calakli; 33737.png.

- 2) There is an object consistent in shape and geometry with a tailwheel as determined by geometric comparison with the tire and fork from a Lockheed Electra Model 10.

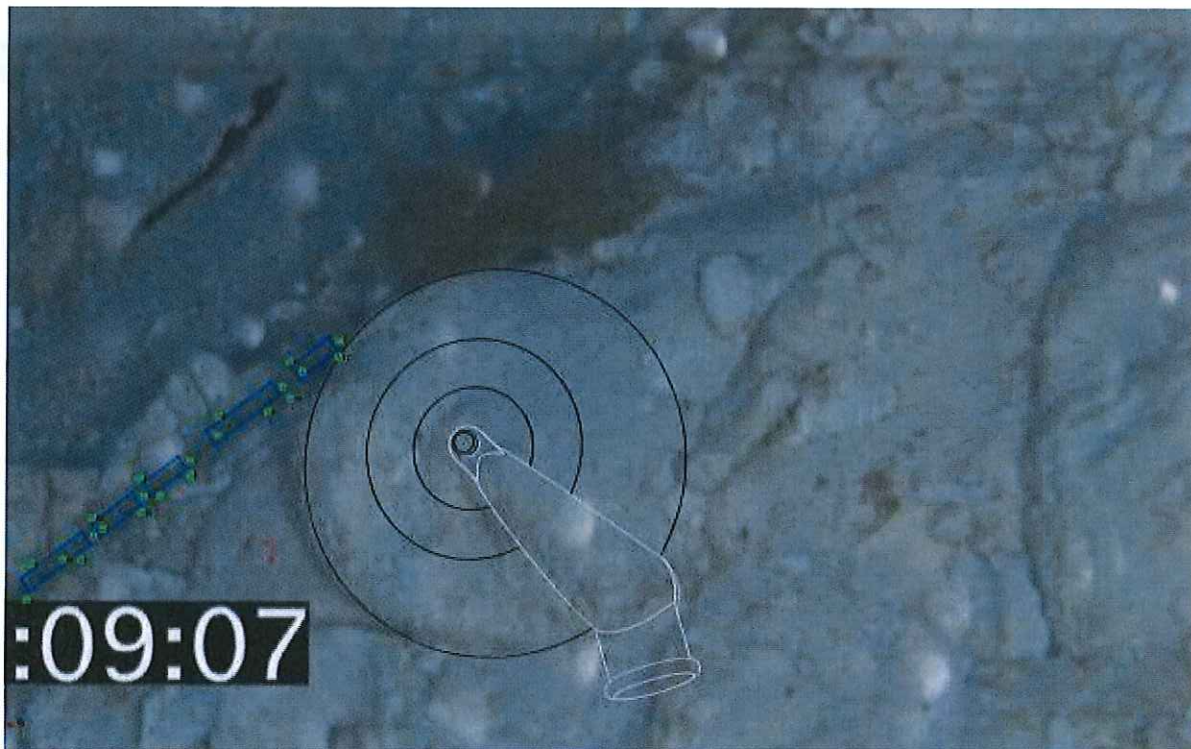
Figure 8: Five segments of the cable were bounded by rectangles, representing the cross-section of the rope. The rope was calculated to have an average diameter of 0.68" with a 0.01" standard deviation based on the CAD model of the tailwheel.

Using the dimensional information available in the CAD models and the assumption that the cable was on the same plane as the bottom of the CAD assemblies resting on the sea floor, the cable was calculated to have an average width of 0.72" with a standard deviation of 0.06" based

on the tailwheel's dimensions and an average width of 0.78" with a standard deviation of 0.05" based on the front landing gear's dimensions. These measurements were taken within the CAD modeling software. Independent measurements confirming the same width Master of Science in Engineering Sciences of the cable suggest that the size and shape of the proposed features on the sea floor are consistent with the front and rear landing gear assemblies of the Electra Model 10E aircraft.

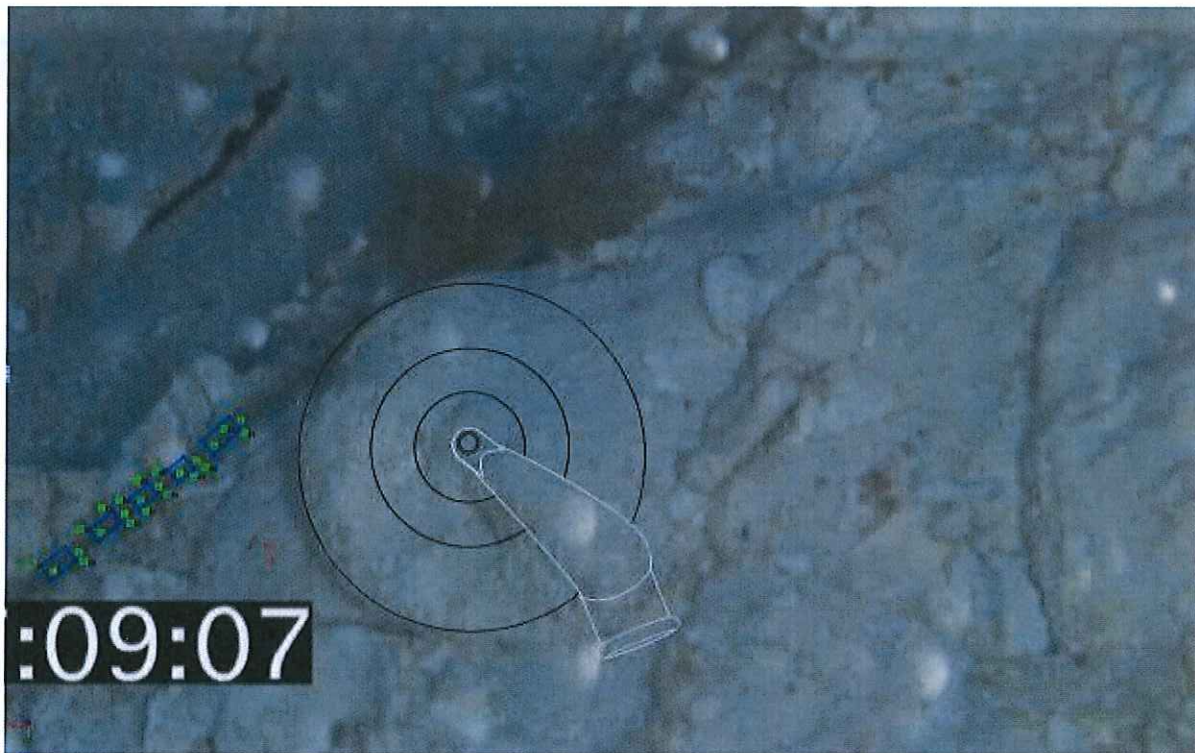
Figure 9: Five segments of the cable were bounded by rectangles, representing the cross-section of the rope. The rope was calculated to have an average diameter of 0.76" with a 0.07" standard deviation based on the CAD model of the tailwheel.
